**ASSESSMENT REPORT ON THE INVESTMENTS
IN NON-WOODEN CULTURAL HERITAGE SITES
SUPPORTED UNDER THE EEA GRANTS PROGRAMME
“CONSERVATION AND REVITALISATION OF CULTURAL
AND NATURAL HERITAGE”**

14 November 2017

Assessment carried out by
Artūrs Lapiņš

Commissioned by:
Lithuanian Ministry of Culture

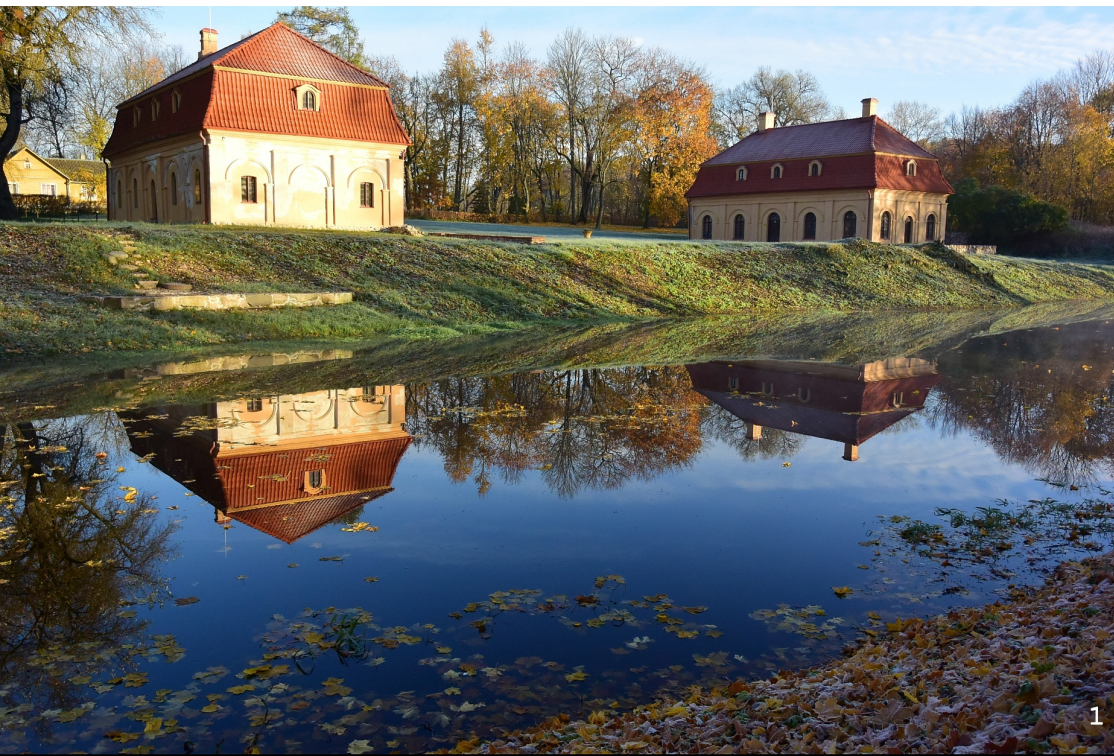
- 1 – Main facade with the restored first floor and reinstalled windows.
- 2 – Fragment of the main facade. Good quality entrance doors; note the derogations in window detailing (too short transom, wider glazing bars of the transom light; the upside-down capital at the base of the impost, which was told to be copied from the 2nd floor partly original window, being obviously a later deviation). The white color of the windows, rather unusual to this type of facade, was told to be found on the second floor windows, although no color investigation report has been attached to the documentation.

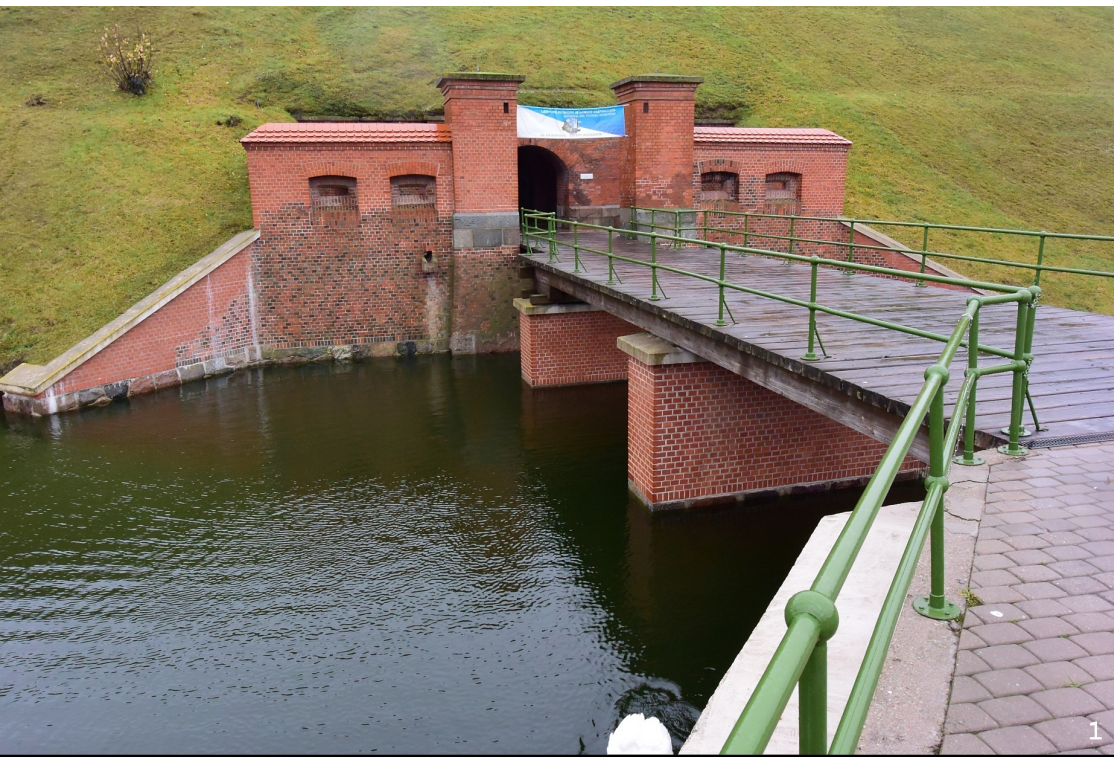
- 1 – view of the main entrance gate and the Bridge. White outflows on supporting walls on both sides might indicate local leaking..
- 2 – view of the cleaned moat. On the right side the cables have been hidden by the cement plate. Hopefully the moss will cover it with ages, as currently it looks too bright and fresh.

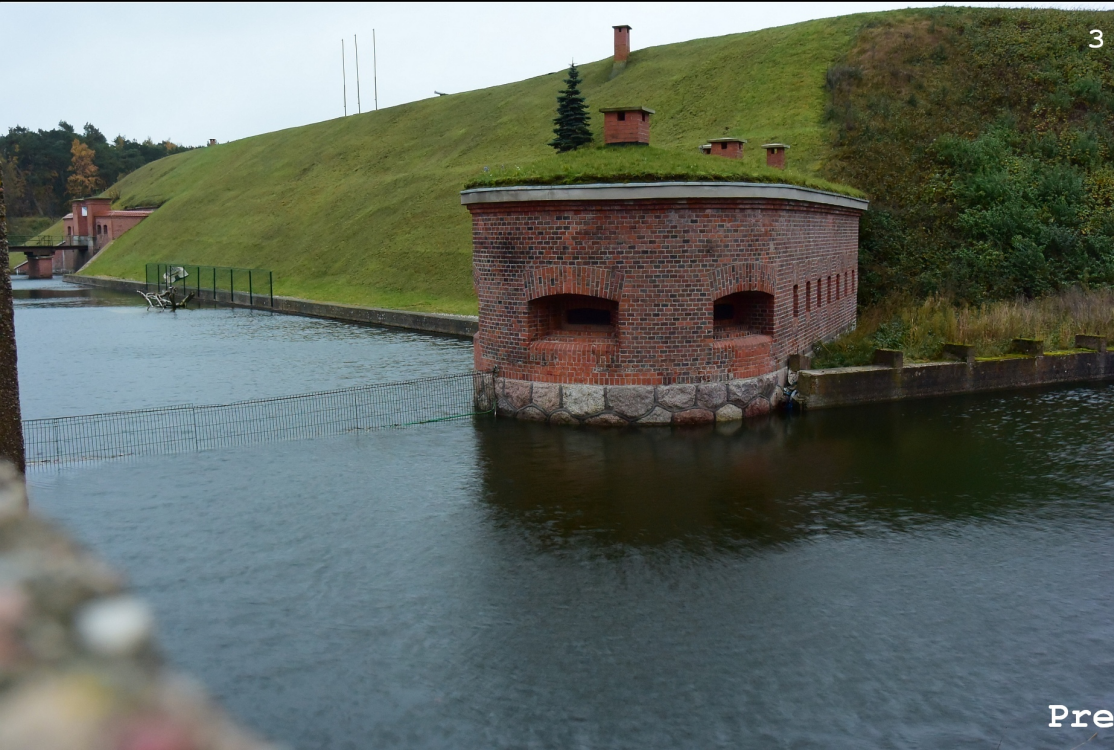
The Casemate's roofs have ventilation chimneys, built in 1970ies. They are too small for the openings in the vaults, and also their shape is inappropriate to the period. The roof insulation has been repaired, so this was the right time also to remodel the chimneys.

- 3 – External facade of Casemate A. The bricks in the sills have been thoroughly supplemented. The ventilation chimneys do not correspond to the round shape of the original openings in the vaults; the shape of the caps is visually too embossed.

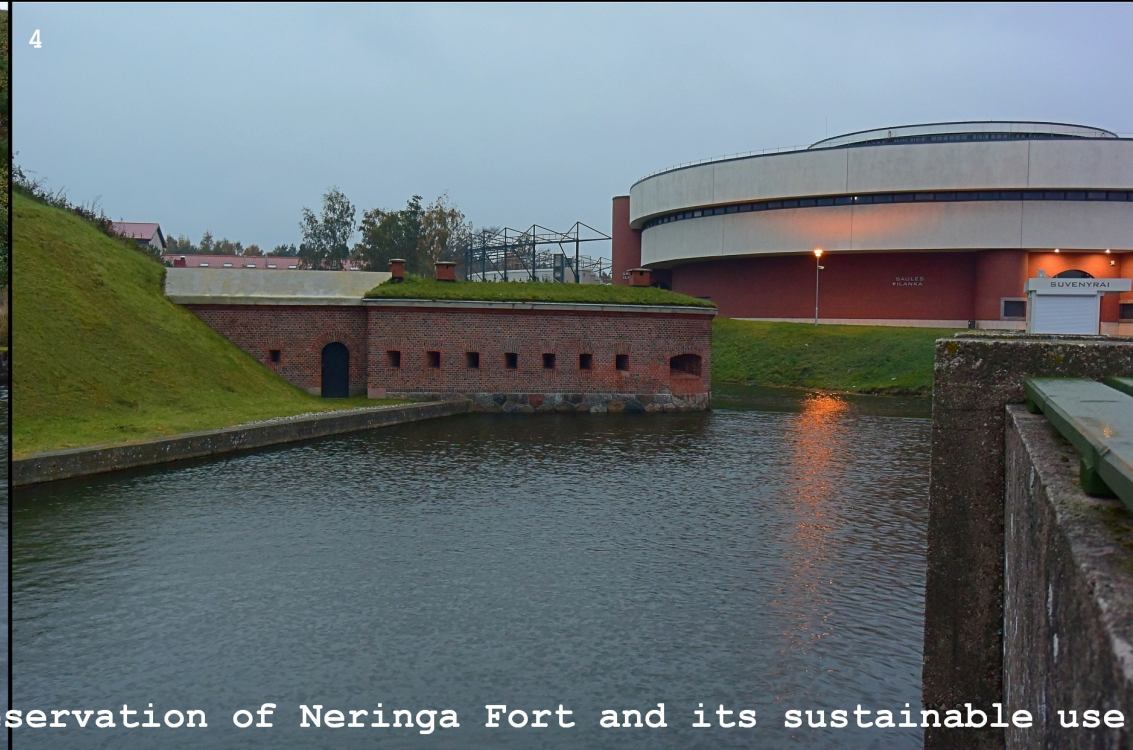
- 4 – side view of the Casemate A. Restored facade and the cleaned moat. In the course of time the white concrete roof will be overgrown with moss, returning to the original outlook.

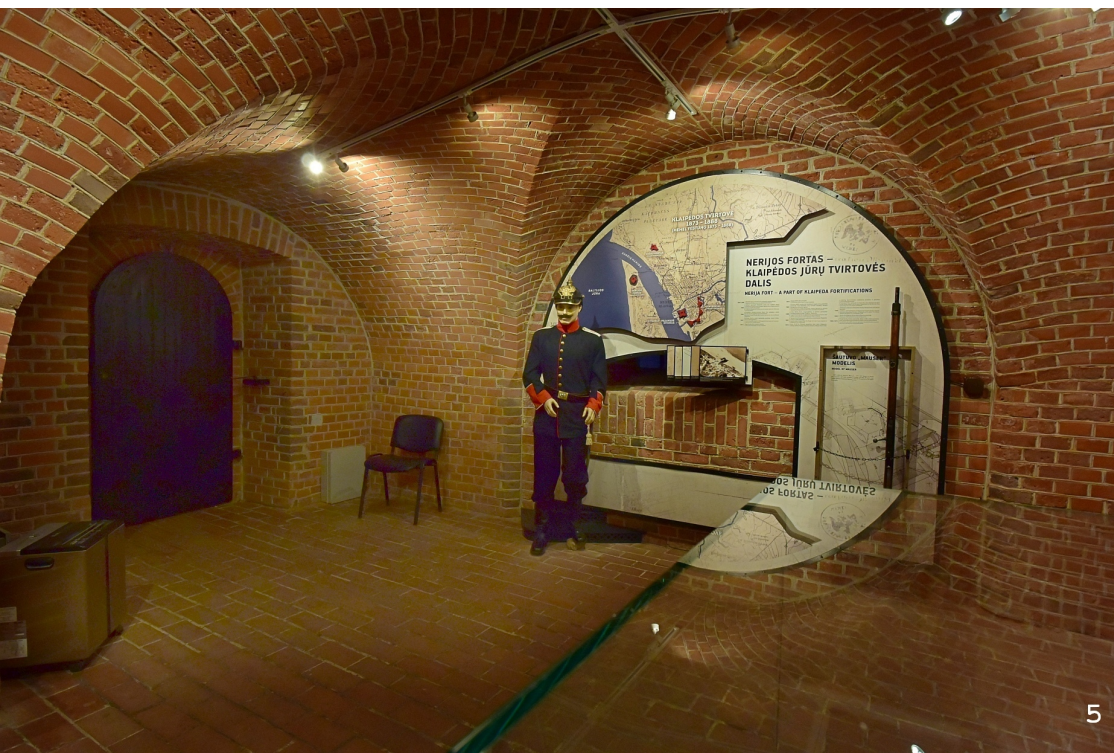
- - -
- 5 – interior of the Guard room. The repointing has been done, referring to the existing, which was applied during the previous restoration in 1970ies. The only window of the room is obscured by the exposition.

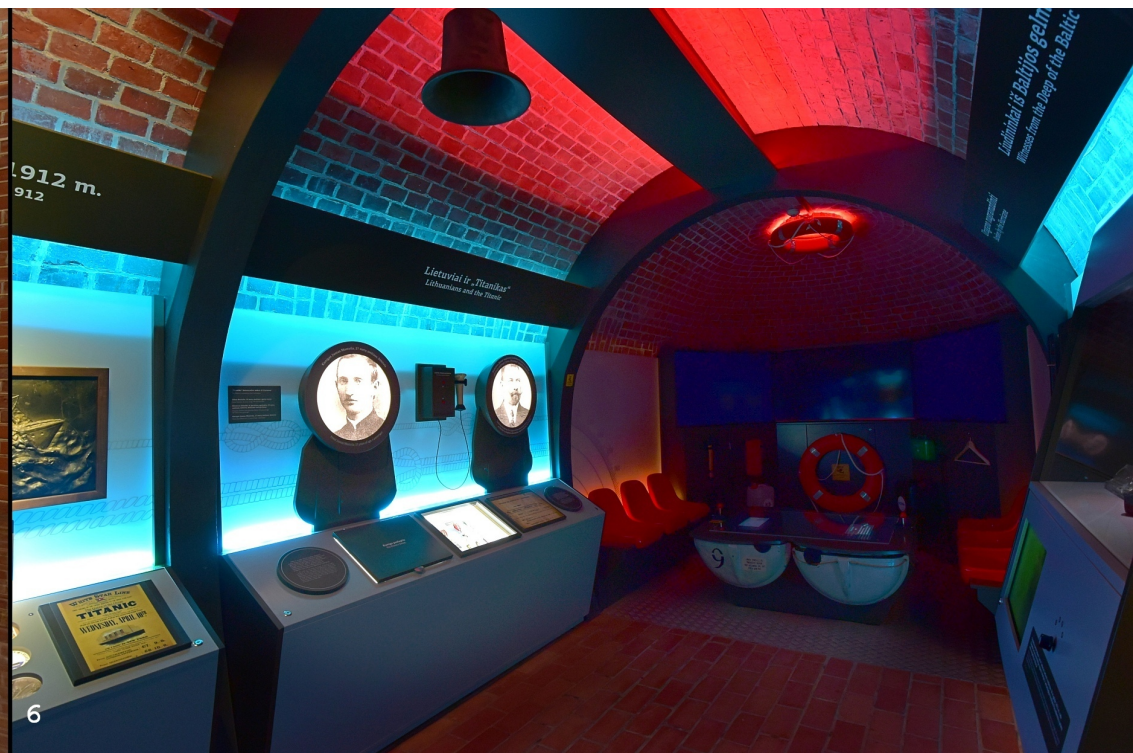
- 6- exposition in Casemate B. Closing of the windows has been chosen, making it hard to orientate yourself inside the premise.
- 7 - exposition inside the Gun-powder cellar. Behind the exposition stands the original ventilation and light shafts can be recognized. The story of how the powder was kept dry and safe waits to be further explored.

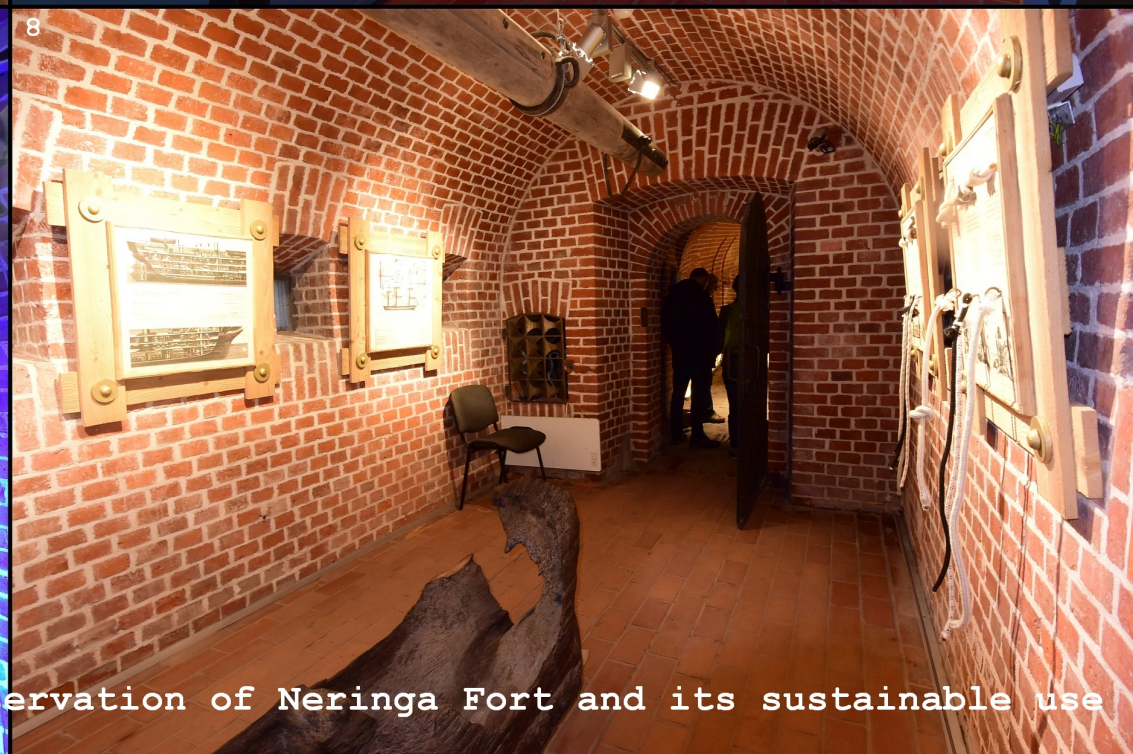
- 8 – Exposition in Casemate C has been carefully installed on the restored walls between the original windows. The former ventilation and hearth shaft in the corner might benefit from the reconstruction of the

original metal door. If would be possible to open at least some of the windows, this together with opened ventilation shafts would create the draught to ventilate out the excess moisture in autumn and spring periods.

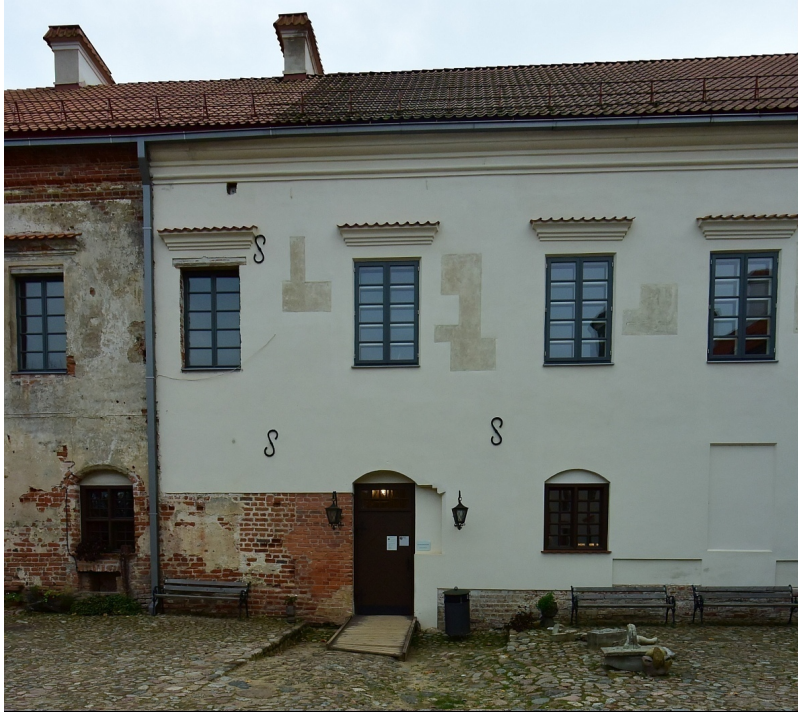
- 1 – Fragment of the yard facade of the South wing. Note the pit in front of the door and the temporary ramp. The windows try to repeat the division of the historic styles, yet the detailing is too modern for a historic site.

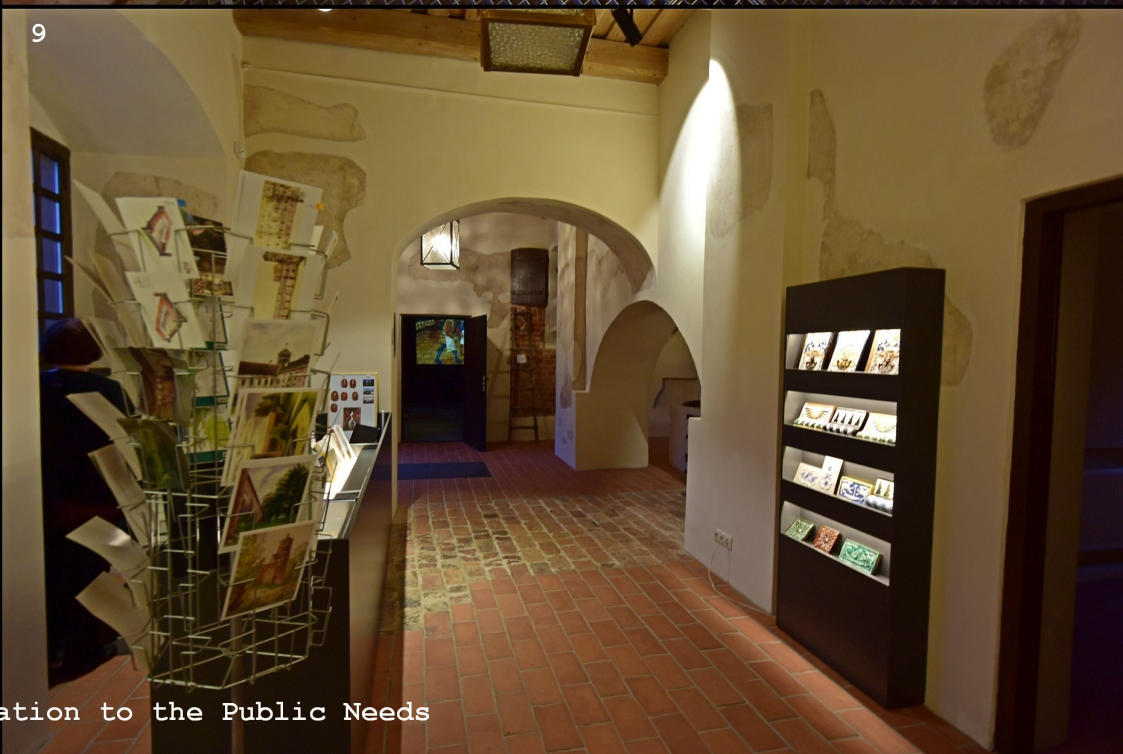
9

9. The Hall. Spotty walls and spotlights work against the restored historic premises.

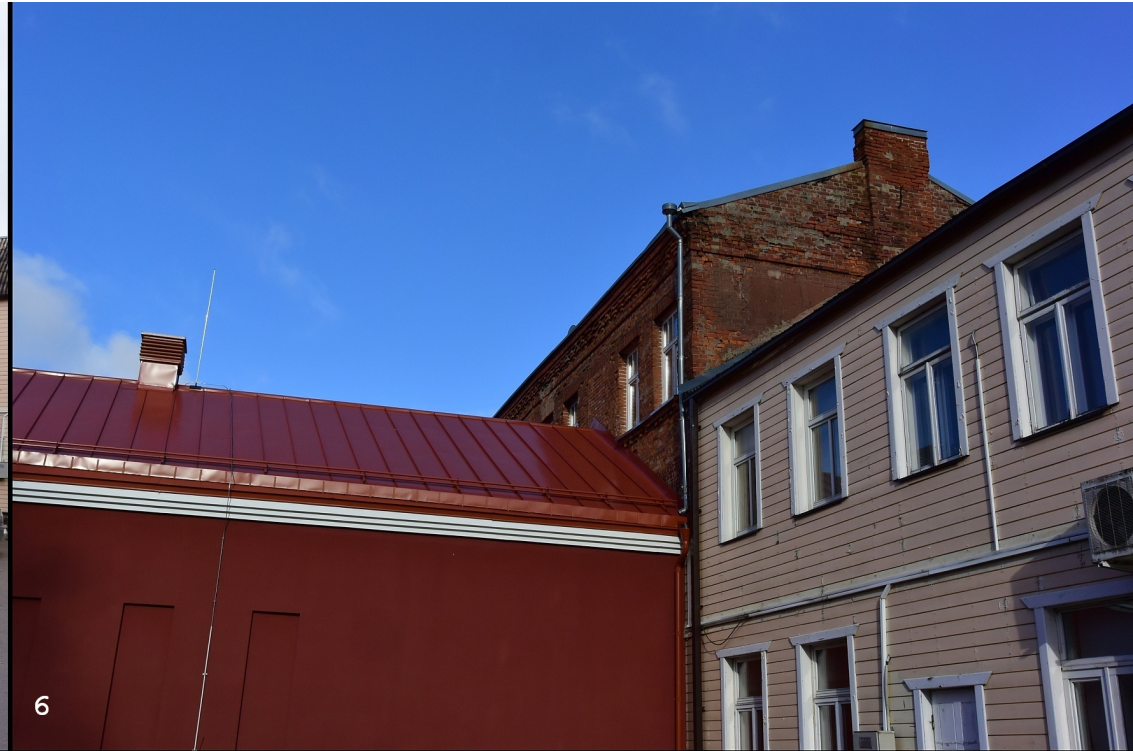
6

6. Fragment of the roof. Note the shiny surface of the tin. A stronger roof gutter might help to avoid installation of the snow barrier.
7. Facade before the works. Note the roof color, shape of the ventilation output.

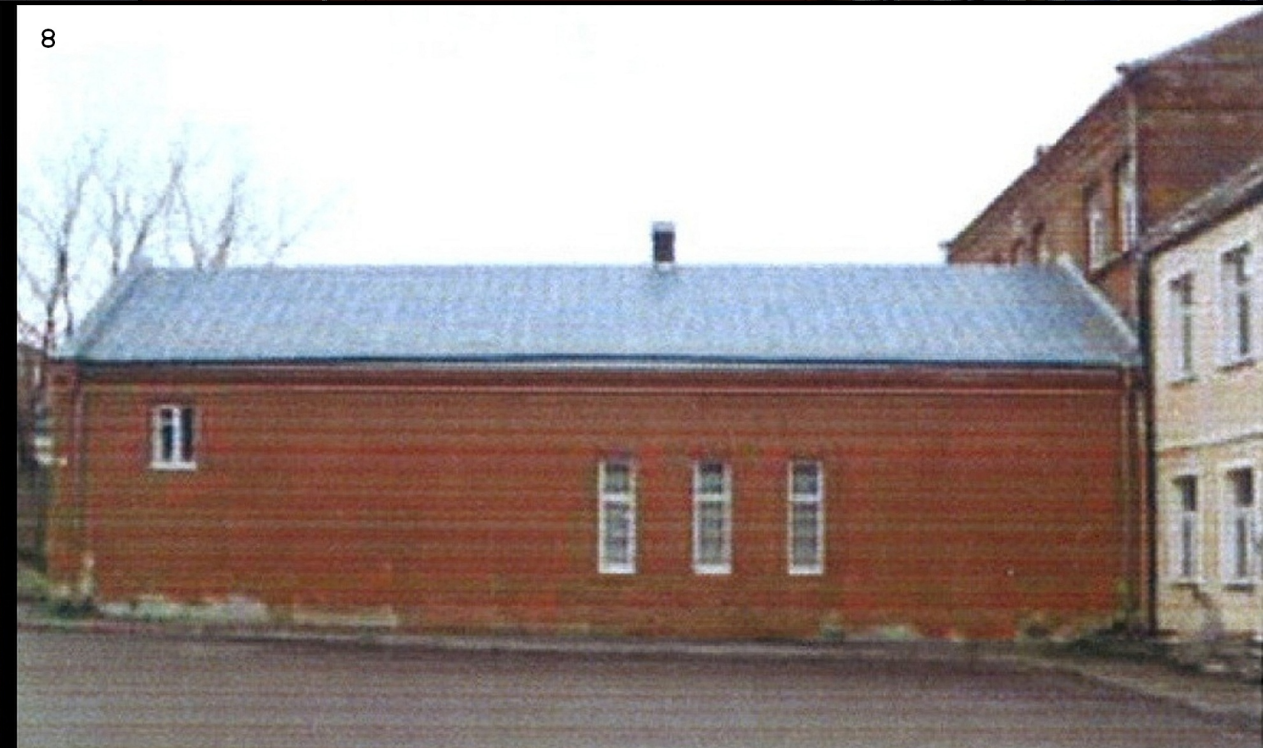
8

8. Facade before the works. The location of the openings still suggests the cinema function. The low base is typical for plastered facades.
